Structural Inspection and Assessment of Yutengping Broken Bridge — A study of masonry historic architecture in Taiwan

Abstract

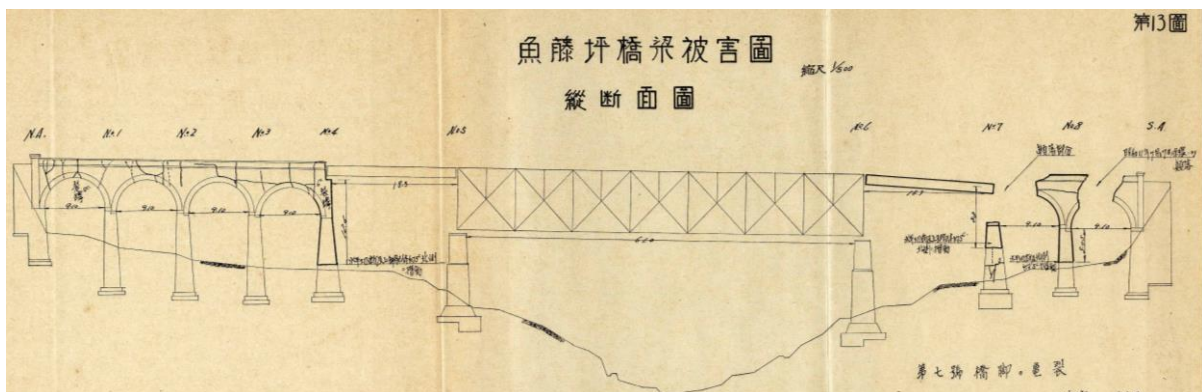
Fig. 2 - The damage of Yutengping Broken Bridge in 1935 earthquake [2]

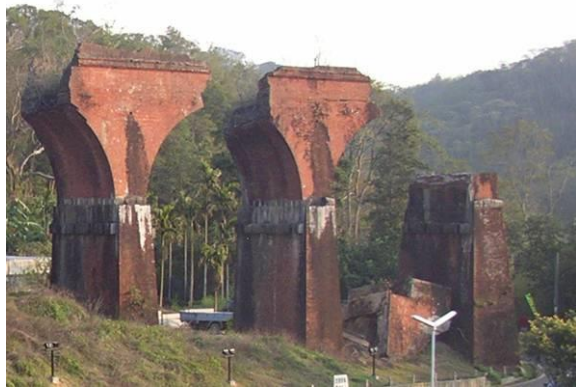
The eccentricity of Pier 4 and Pier 7 is quite visible, and will induce an additional eccentricity moment with the negative effect for the system. So the spandrel of pier 7 was collapsed in the 1935 earthquake. In 1999, the spandrel of Pier 4 pier also collapsed due to the Chi-Chi strong earthquake (Fig. 4).

Fig. 4 - The broken brick arcade in north side, the arch spandrel of pier 4 was collapsed by 1999 Chi-Chi earthquake.

1. All cracks should be filled by injected cement or epoxy mortar.
2. Joints weather out should be re-pointed.
3. Archivolt should be tied by stainless bars embedded to spandrel.
4. In order to prevent further spandrel collapse, a steel arch between adjacent piers is suggested. The arch shape also needs to be designed following the original arch form.
5. Removal of salts and drainage improvement of the arch should be well considered for avoiding accumulation of soluble salts.

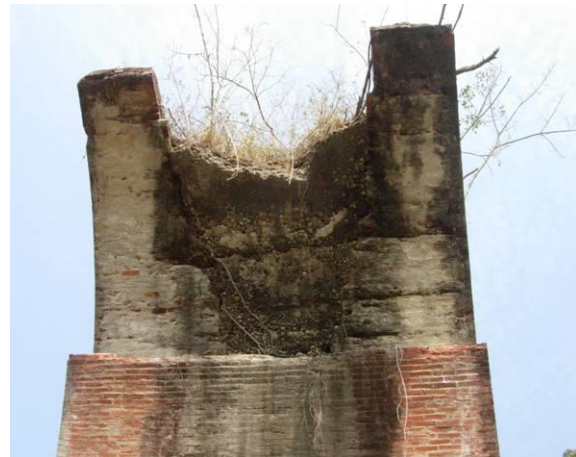
The masonry was constructed in English bond, and the mortar joints are full of mortar with high quality of cement. The archivolt was laid by 6 layers of bricks in header bond. The shape of arch is semicircle with a 9 m diameter. The archivolt was designed to support its upper weight and induce compressive stress, but after the removal of the top of the arch the archivolt lose confined stress, and are easy to drop out (Fig. 5).

Fig. 5 - The archivolt of brick arcade was drop out.

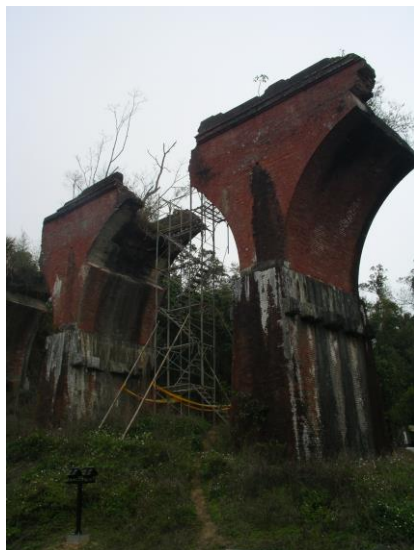
On the top of the spandrel there is a concrete slab for rails and two masonry parapets on each side. Due to this change in shape, the parapet is easy to generate a horizontal crack at its bottom area. Because the scuppers are obstructed, some rainwater will stay on top of the arch and cause accumulation of soluble salts seriously (Fig. 6). Mortar joints will be weather out with time, if the drainage did not be treated properly, the deterioration will be worse.

Fig. 6 - Accumulation of soluble salts of Pier 1 and Pier 2

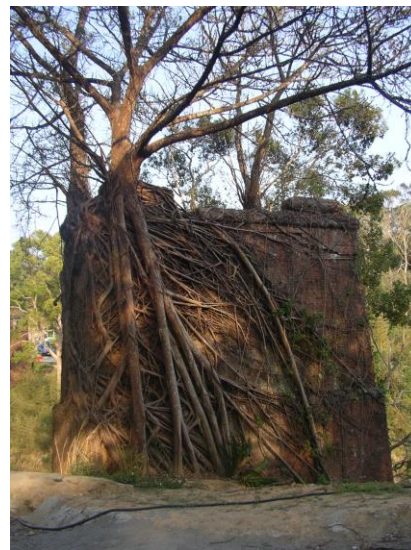
Plants attached also are harmful from the point of structural safety, the root of the plant will penetrate the masonry, and the weights of the plants also induce much great loading (Fig. 7).

Fig. 7 – Tree attached to Pier 6.

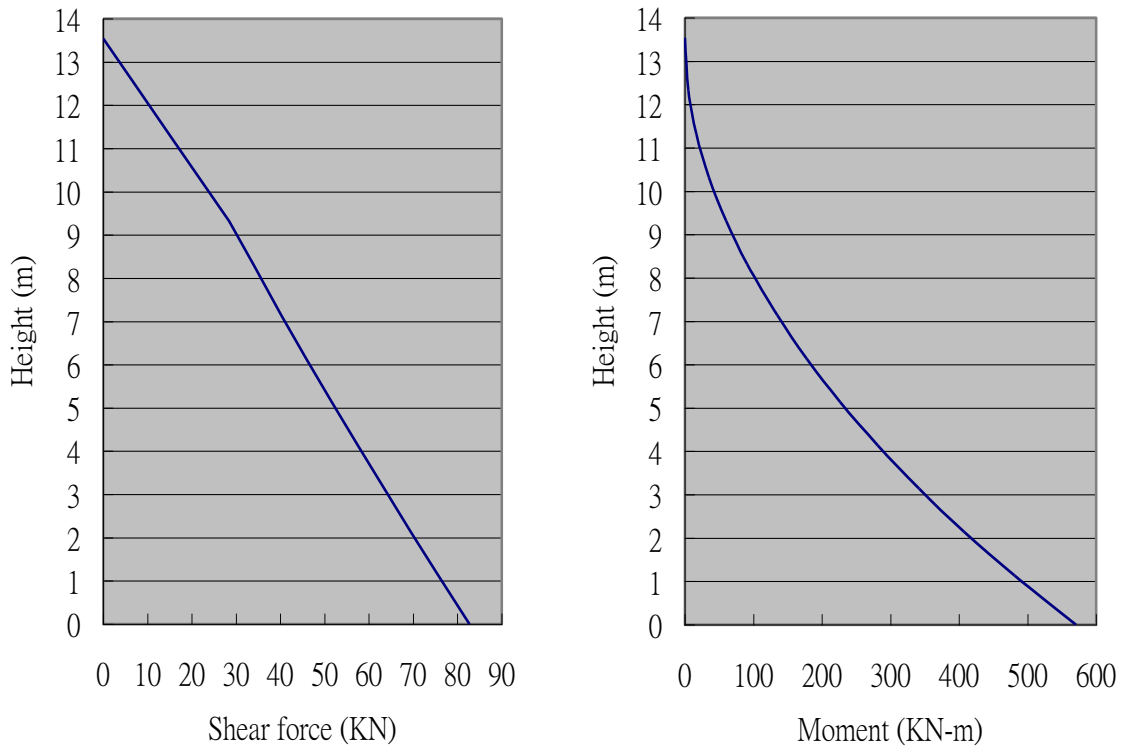
The wind pressure and seismic base shear are calculated to assess the safety of the existing piers. The calculation follows the present building code used in Taiwan, The maximum wind base shear of Pier 3 is 82.7KN with 570.6KN-m moment in N-S dir. The internal force of Pier 3 in different height is shown in Fig. 12.

Fig. 12 - Shear force and moment of Pier 3 pier due to design wind pressure

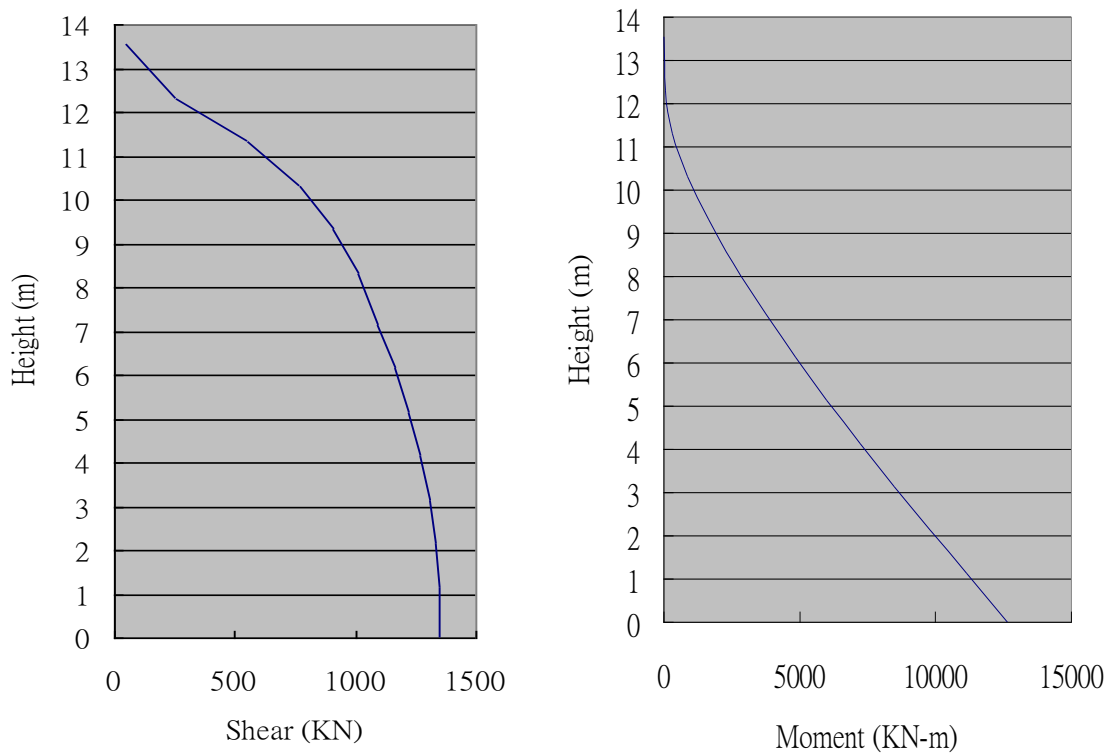
To determine the design seismic load required by present design code, the dominant vibration period identified in ambient vibration measurement is applied. Because the site of the bridge is near two faults, the near fault effect also has to be involved. The maximum seismic base shear of Pier 3 is 1348.9KN with a 12665KN-m moment as shown in Fig. 13.

Comparing these 2 loadings, obviously, the seismic load governs the safety of the structure, so only the seismic stress is calculated and discussed. The seismic stress of Pier 3 is shown in Table 5. Although maximum shear force and moment will be at the base of a cantilever system, the maximum shear stress is found near the impost not at the base part. This is because the cross-sectional area near the impost is the smallest in the pier.

Fig. 13 - Shear force and moment of Pier 3 due to design earthquake base shear
