Structural Inspection and Assessment of Yutengping Broken Bridge — A study of masonry historic architecture in Taiwan

Abstract

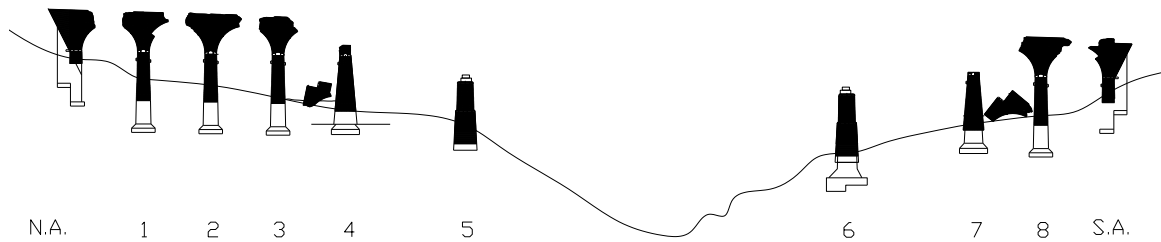
maintenance has been put by the railway administration bureau, the damage situation of the bridge gets worse gradually. Thus in the 1999 Chi-Chi earthquake the spandrel of Pier 4 collapsed.[3] After the earthquake damage, the safety of the broken bridge caused attention widely, and the conservation is decided by the local government (Fig. 3).

Fig. 3 - Existing Yutengping Broken Bridge [4]

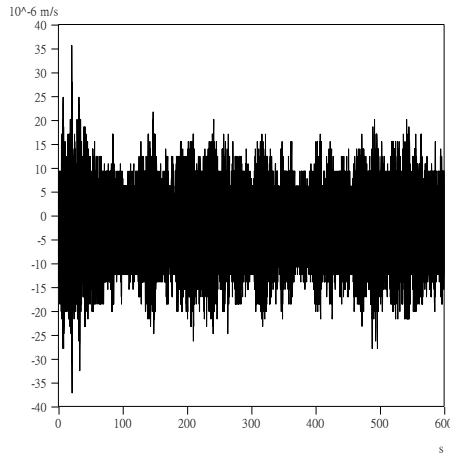
To understand the dynamic properties of the existing piers, ambient vibration measurement was processed. The piers measured are Pier 1, Pier 2 and Pier 8. After the measurement, the recorded data in time domain were converted to frequency domain by Fast Fourier Transform. Using the obtained frequency spectrum, we can calculate the transfer function between top of the pier and ground for the ambient vibration. The identified fundamental natural frequencies of measured piers are about 4.6Hz to 6.0Hz in E-W direction and 2.8Hz to 3.2Hz in N-S direction. Obviously, the pier stiffness in E-W direction is greater than that in N-S direction. Although these 3 piers were built in the same shape and size, their height is different due to the slope of the ground. The height of Pier 2 is higher than the two others, so its vibration period is longer than that of the other 2 piers. For Pier 8, some large trees attached, and some roots grows in the cracks of the pier. These situations may induce greater wind loading and a longer vibration period for the pier. So although the height of Pier 1 and Pier 8 is close near, Pier 8 got a longer vibration period in N-S dir. During measuring Pier 8 in site, we did experience the wind effect on pier vibration. The recorded ambient vibration time history of Pier 1 and Pier 8 are shown in Fig. 8 and Fig. 9. From Fig 9, we can see the longer period for pier 8, which is influenced by wind on the trees.

Fig. 8 - The recorded ambient vibration time history of Pier 1 for N-S dir.

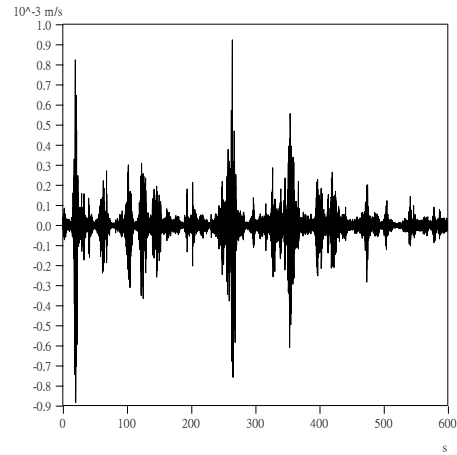
Fig. 9 - The recorded ambient vibration time history of Pier 8 for N-S dir.

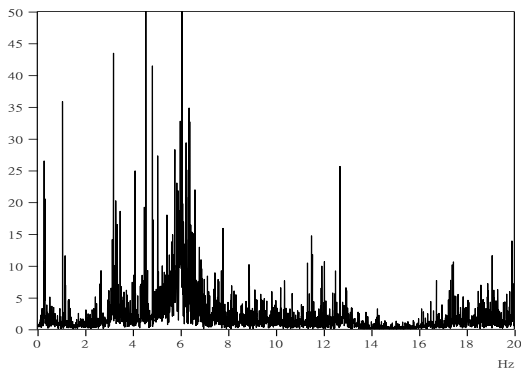
In Fig. 10 and Fig. 11 the transfer function of Pier 1 in E-W and N-S directions are also shown. The identified period in E-W direction is shorter than that in N-S direction; this is because the section module corresponding to N-S axis is much greater.

Fig. 10 - Transfer function of Pier 1 pier in E-W direction, $f_{EW} \approx 6.0\text{Hz}$

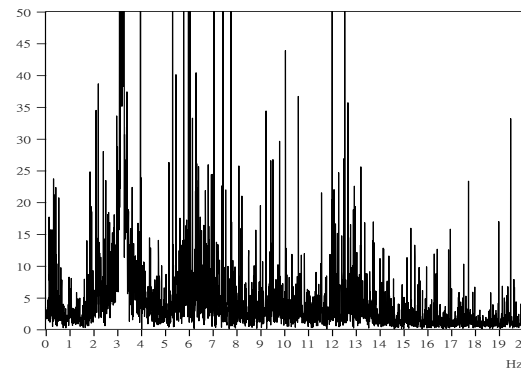
Fig. 11 - Transfer function of Pier 1 pier in N-S direction, $f_{NS} \approx 3.2\text{Hz}$
